# Home Report

# Scottish Single Survey

| Property address | The Manse<br>Wallyford Loan Road<br>Wallyford<br>Musselburgh<br>EH21 8BU |
| Date of inspection | 08/08/2025 |

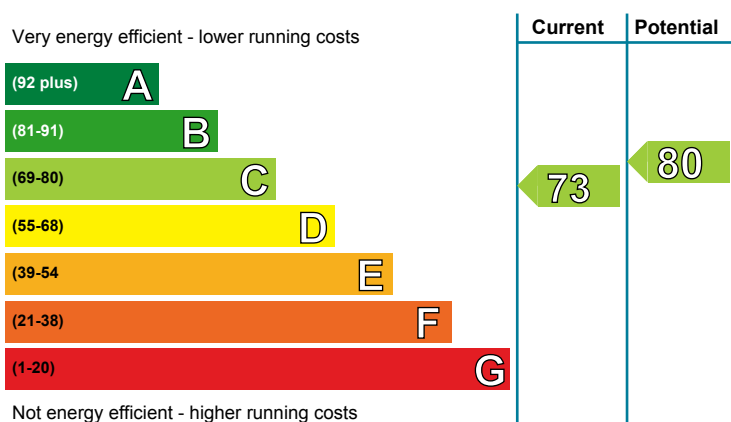
## Energy Efficiency Rating

This graph shows the current efficiency of your home, taking into account both energy efficiency and fuel costs. The higher this rating, the lower your fuel bills are likely to be.

Your current rating is **band C (73)**. The average rating for EPCs in Scotland is **band D (61)**.

The potential rating shows the effect of undertaking all of the improvement measures listed within your recommendations report.

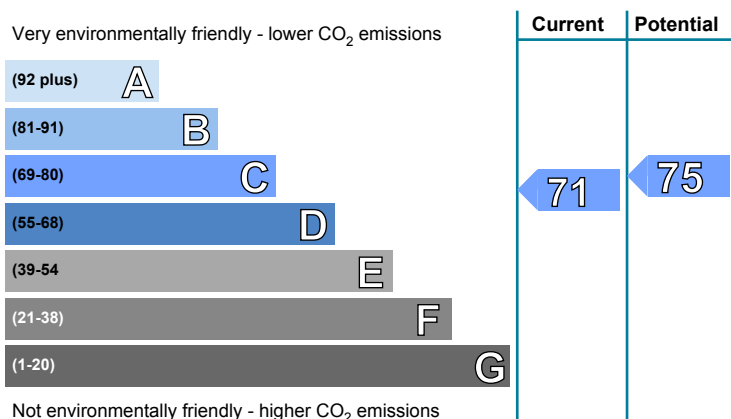
## Environmental Impact (CO<sub>2</sub>) Rating

This graph shows the effect of your home on the environment in terms of carbon dioxide (CO<sub>2</sub>) emissions. The higher the rating, the less impact it has on the environment.
