## **Home Report**

THE MANSE BETTYHILL

THURSO  
KW14 7SS

# Energy Performance Certificate (EPC)

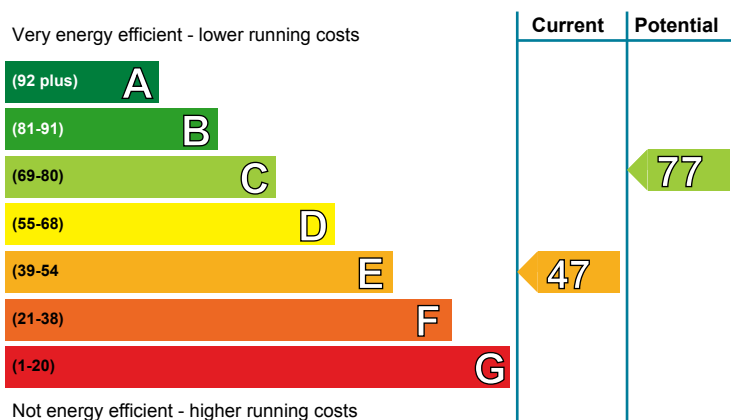
## Energy Efficiency Rating

This graph shows the current efficiency of your home, taking into account both energy efficiency and fuel costs. The higher this rating, the lower your fuel bills are likely to be.

Your current rating is **band E (47)**. The average rating for EPCs in Scotland is **band D (61)**.

The potential rating shows the effect of undertaking all of the improvement measures listed within your recommendations report.

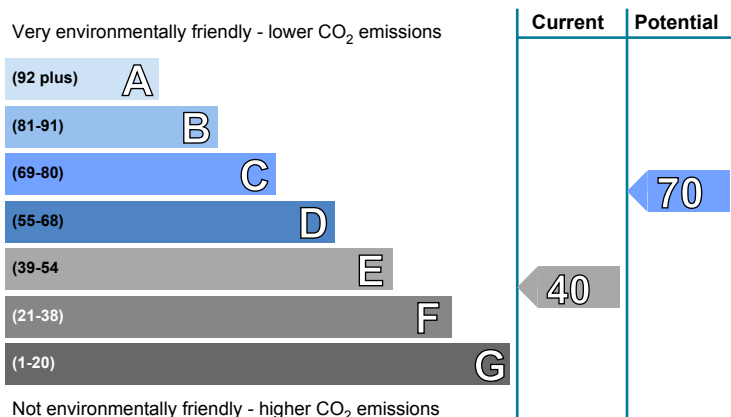
## Environmental Impact (CO<sub>2</sub>) Rating

This graph shows the effect of your home on the environment in terms of carbon dioxide (CO<sub>2</sub>) emissions. The higher the rating, the less impact it has on the environment.

Your current rating is **band E (40)**. The average rating for EPCs in Scotland is **band D (59)**.

The potential rating shows the effect of undertaking all of the improvement measures listed within your recommendations report.
